SAN JUAN CREEK WATERSHED MANAGEMENT STUDY ORANGE COUNTY, CALIFORNIA

FEASIBILITY PHASE

F-5 REPORT

AUGUST 2002

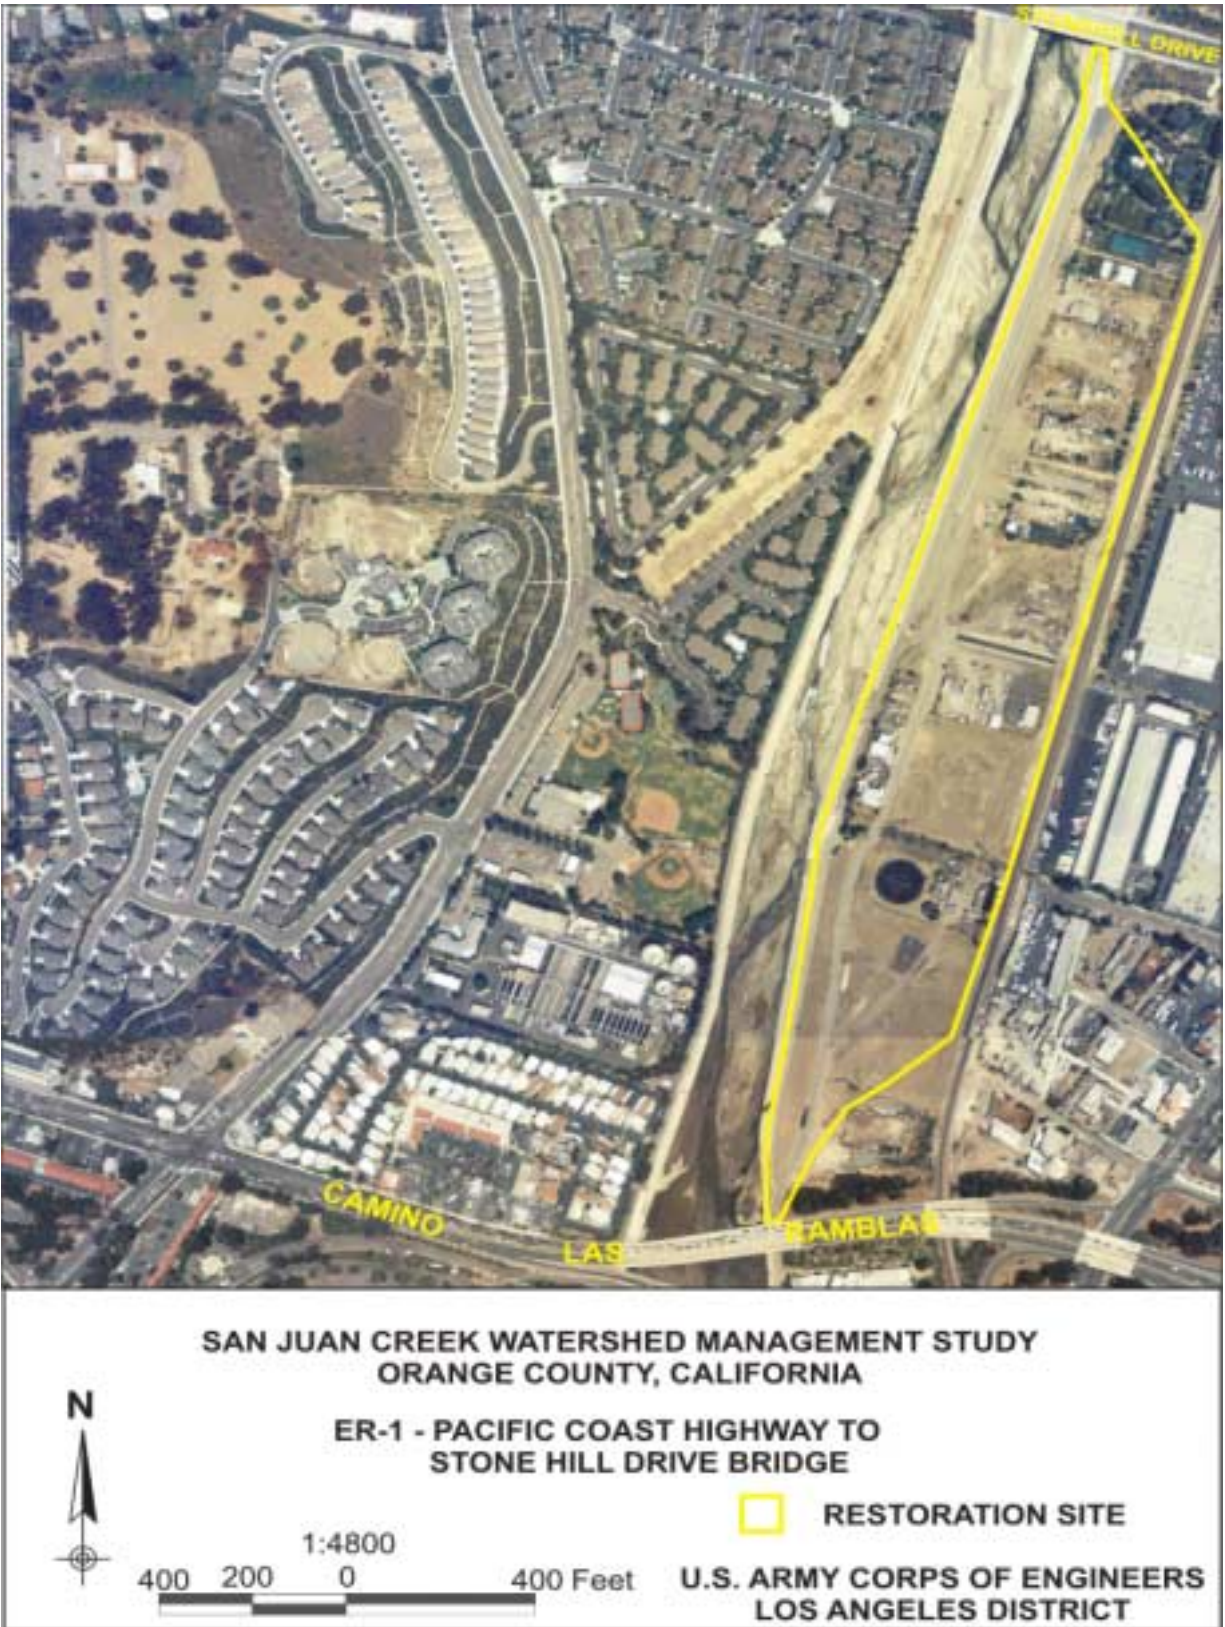
Figure 25. ER-1 Pacific Coast to Highway to Stonehill Drive Bridge

This restoration alternative consists of the excavation of the east (south) bank of San Juan Creek between Camino Las Ramblas bridge and Stonehill Drive bridge to the level of the existing invert (Figure 25). The excavated area would be utilized as a riparian zone with reconstructed wetlands, riparian and upland plantings, and general reestablishment of a broad riparian community in the downstream reach of San Juan Creek. Restoration of the area would include removal of non-native vegetation, revegetation of native wetland, riparian, and upland species, and construction of a setback levee to contain flows.

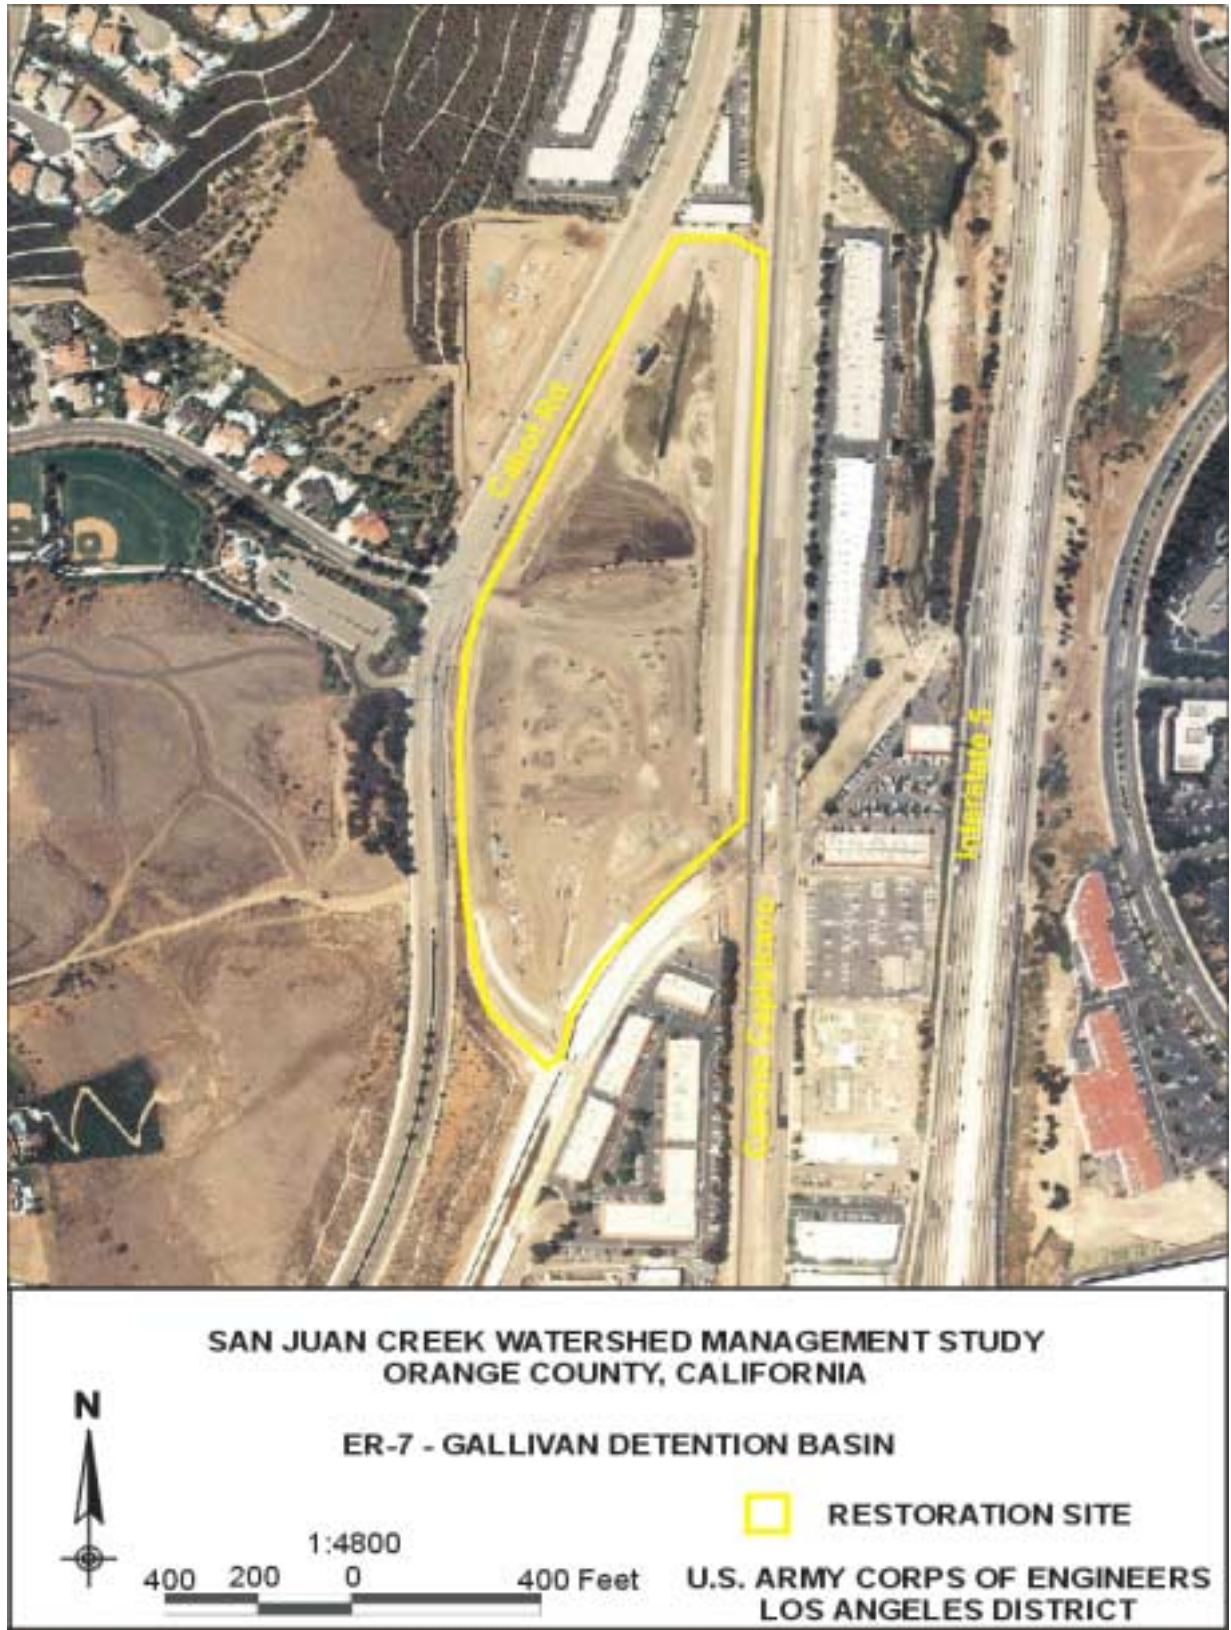
Figure 32. ER-7 Gallivan Detention Basin

This restoration alternative consists of the excavation within the Galivan Detention Basin on Oso Creek upstream of Station 153+00, a distance of approximately 700 meters (Figure 32). The excavated area would be utilized to reestablish wetlands, riparian, and upland habitats within the basin confines. Recreation of upland habitat would create a transition zone between existing development and the riparian zone. The entire area would be enlarged and enhanced for greater habitat value. Restoration of the area would include clearing and stripping, removal of non-native vegetation, and revegetation of native wetland, riparian, and upland species.

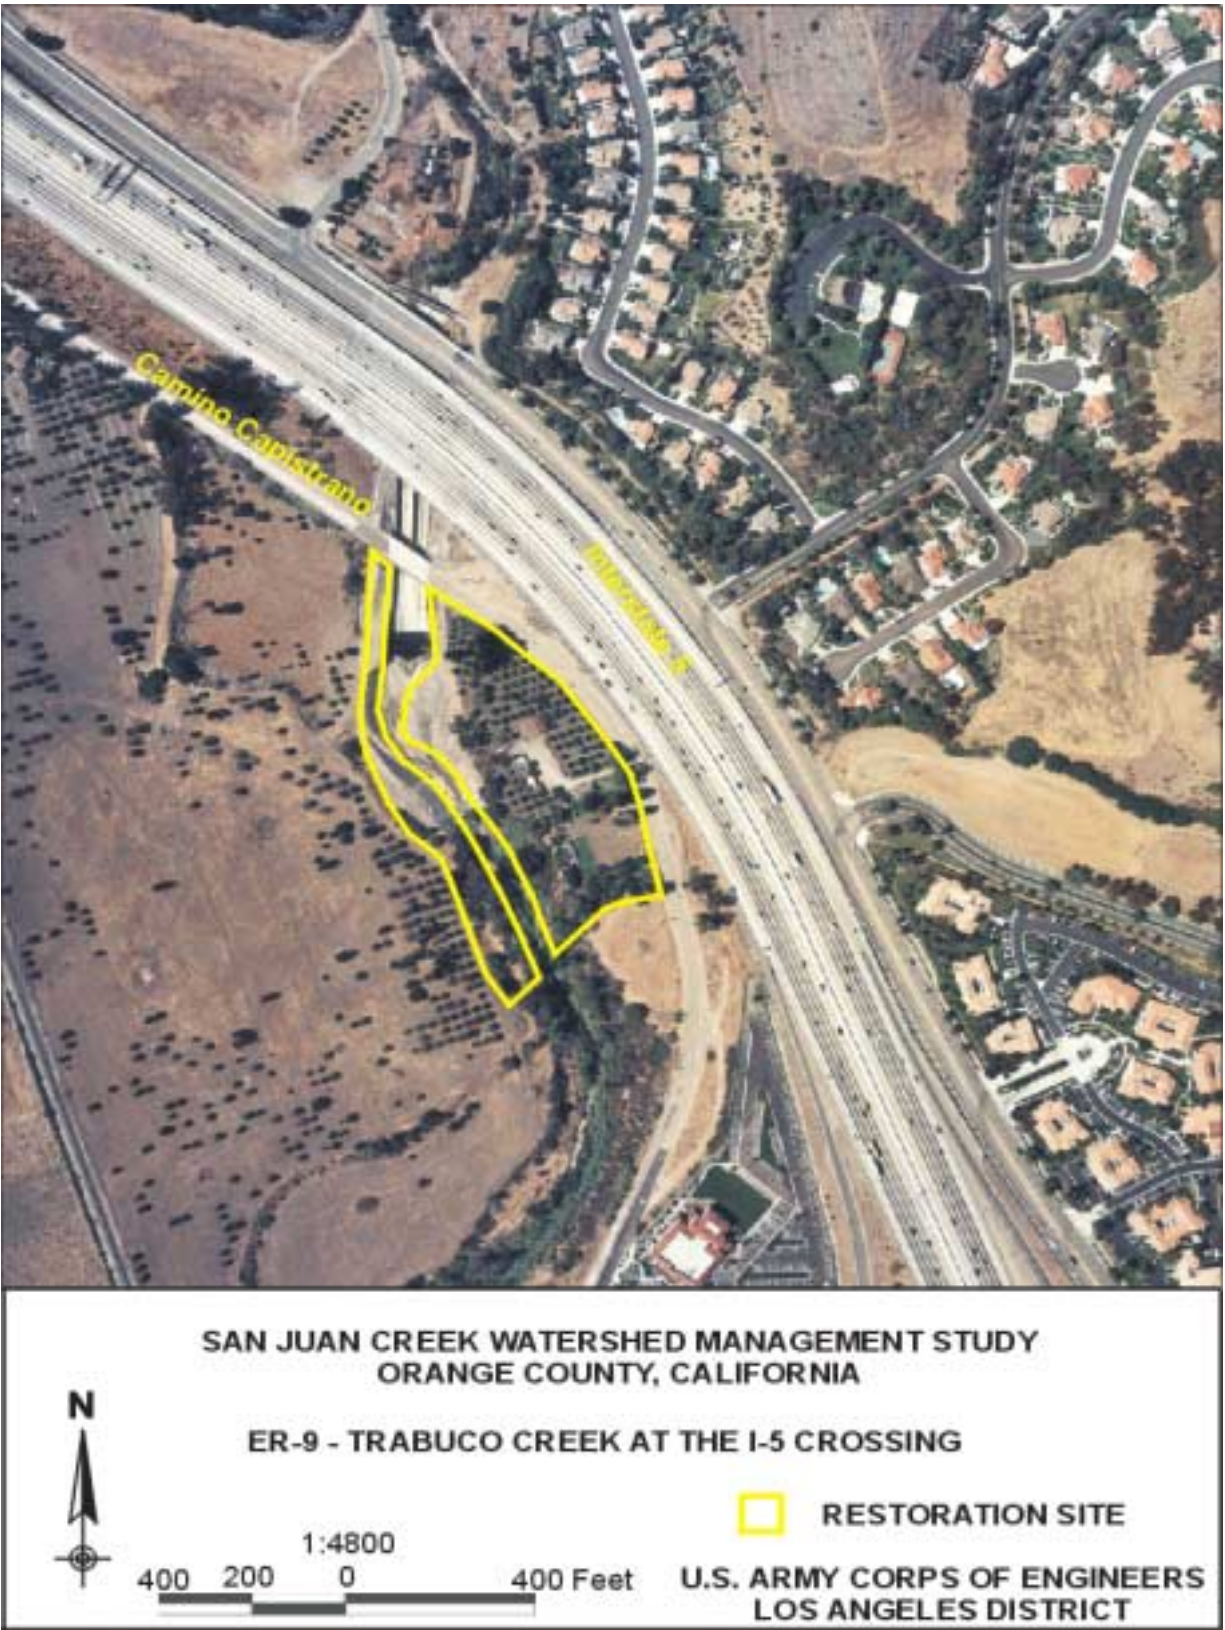
Figure 34. ER-9 Trabuco Creek at the I-5 Crossing

This restoration alternative consists of the excavation of both banks of Trabuco Creek immediately downstream of the Interstate 5 bridge, for a distance of approximately 300 meters (Figure 34). The excavated area would be utilized to extend the riparian zone inland and recreate the upland transition zone between existing development and the riparian zone. The entire area would be enlarged and enhanced for greater habitat value. A series of weirs/grade stabilizers would be installed to recreate the “steps” in the former profile that safely dropped floodflows to a lower level downstream. Restoration of the area would include clearing and stripping, removal of non-native vegetation, and revegetation of native wetland, riparian, and upland species.

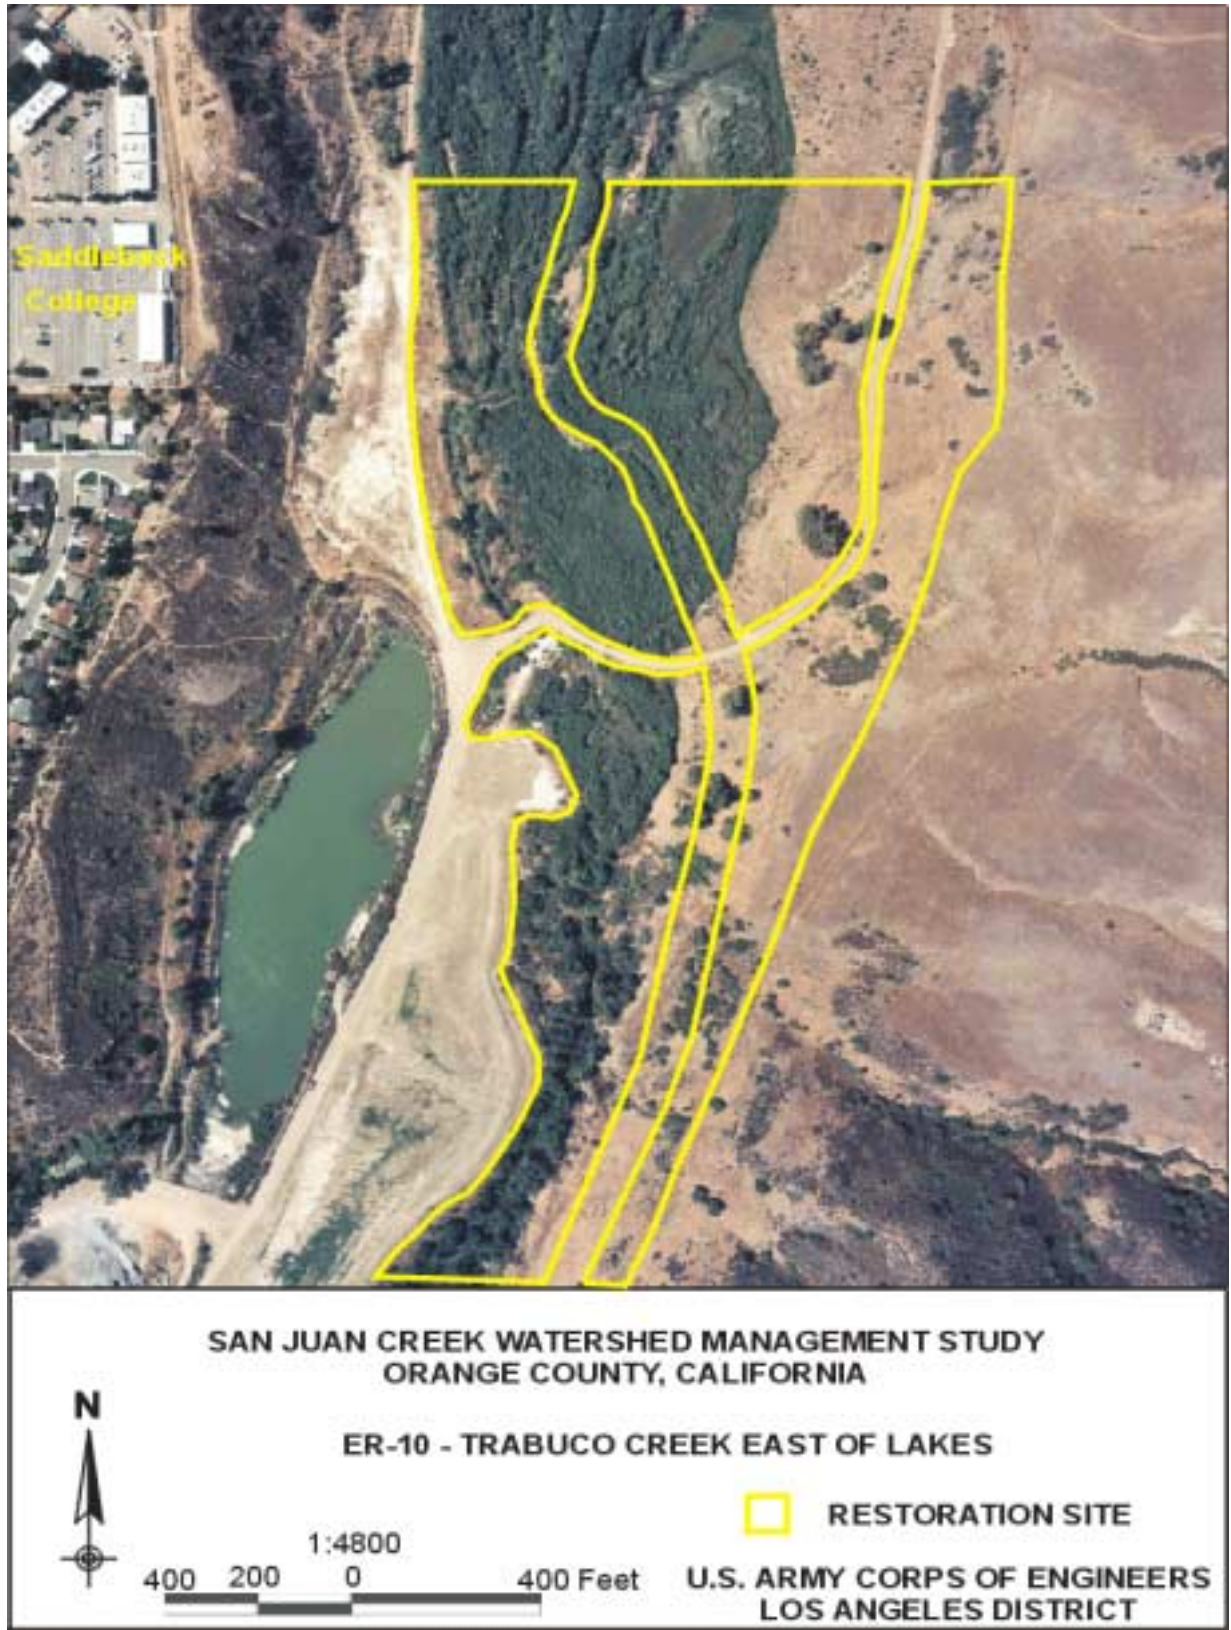
Figure 35. ER-10 Trabuco Creek East of Lakes

This restoration alternative consists of the excavation of both banks of Trabuco Creek between Station 165+00 and Station 175+00, a distance of approximately 1,000 meters (Figure 35). The excavated area would be utilized to extend the riparian zone inland and recreate the upland transition zone between existing development and the riparian zone. The entire area would be enlarged and enhanced for greater habitat value. Restoration of the area would include clearing and stripping, removal of non-native vegetation, and revegetation of native wetland, riparian, and upland species.
